OMEGA YACHT SERVICES Glenmist, Mount Pleasant, Stoford, Salisbury, SP2 0PP Tel: 07702 915524

Pre-purchase, Condition, Insurance and Valuation Report

Merlin

3) Vessel details		
Vessel type	Motor Vessel	
Model	Sealine S28	
Builder	Sealine International Ltd	
Designer	Tom Murrant	
Identification	Registration number none displayed Year of construction 2004	Serial number 393 Hull number GB-SIL28393K405
Engine	Volvo Penta KAD32P x 2	
Accommodation	Four berths in two cabins	
Dimensions listed from	Manufacturer's website	
Dimensions	Overall length 8.8m Beam 3.1m	Hull length 8.2m Draft 1.0m
Fuel capacity	400 litres	
Water capacity	280 litres

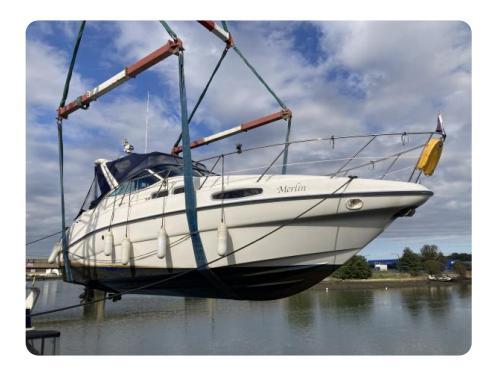
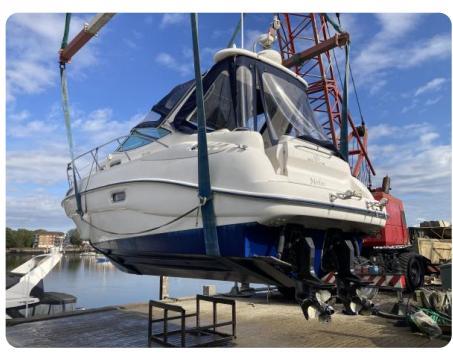
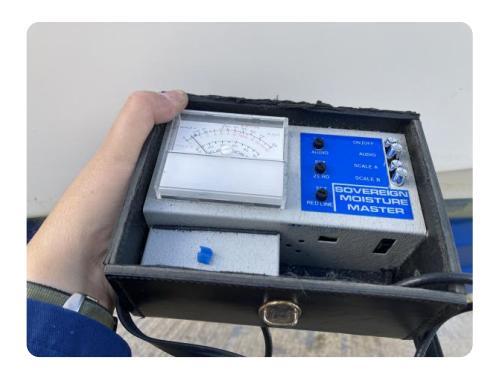
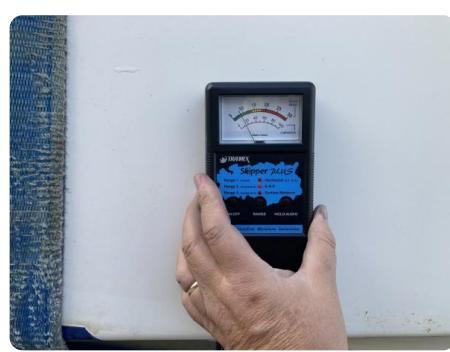
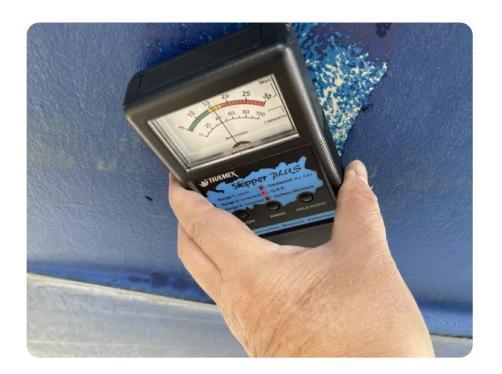
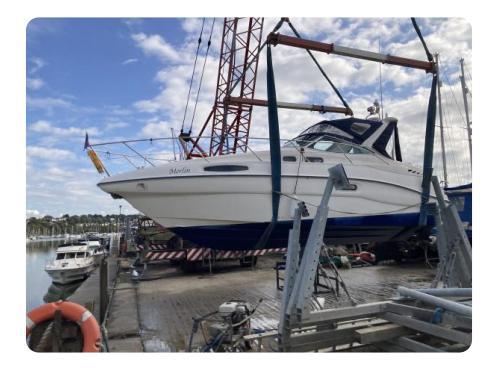
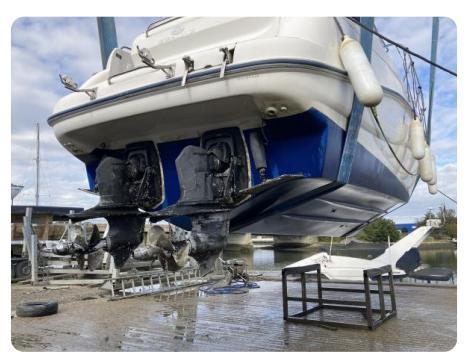
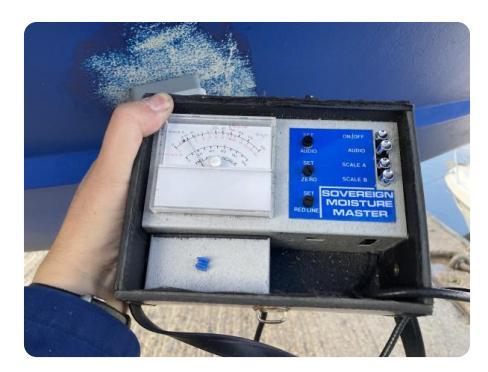
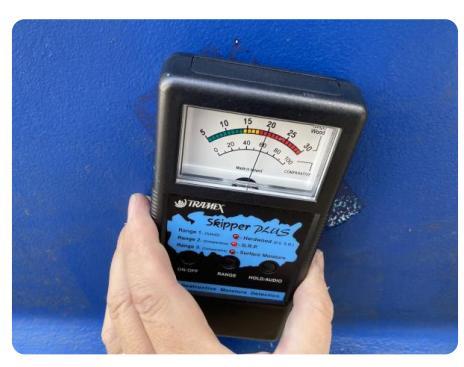
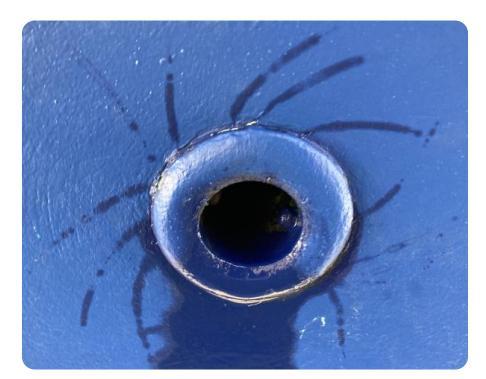
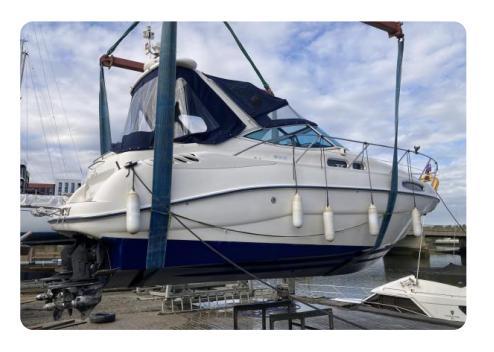
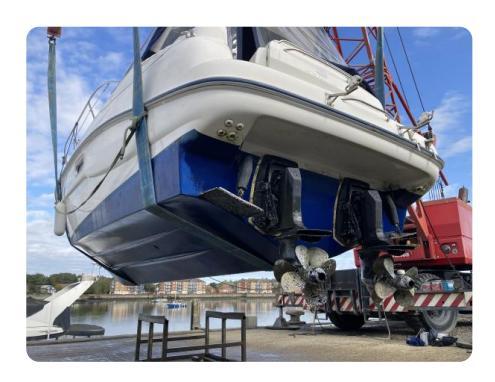
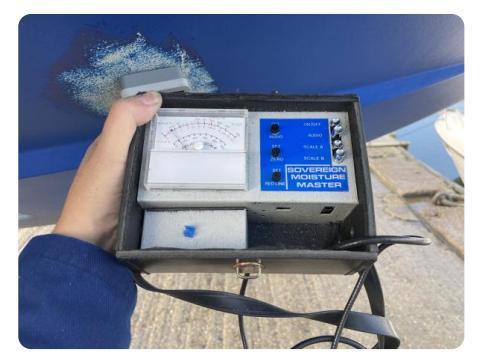
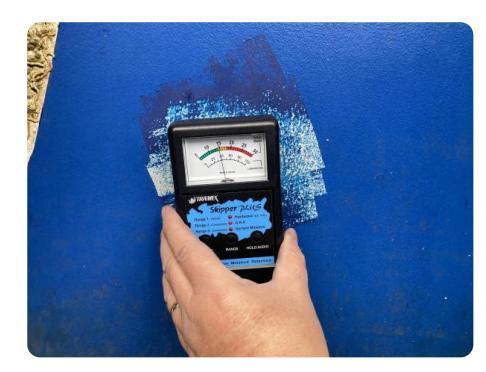
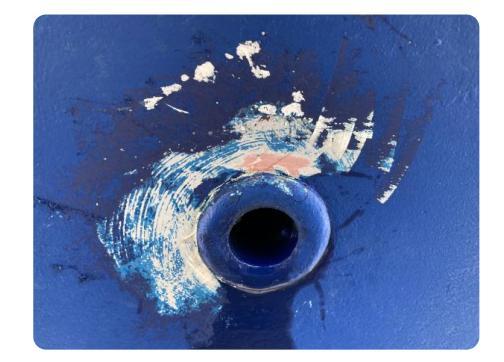
Several cracks due to accident damage were noted all over the topsides and bathing platform. Cracks were found on the starboardside of the hull below the waterline around the sea toilet outlet skin fitting. It is likely that the sea toilet outlet seacock's handle has been forced in the past casing the hull to flex and crack. The damaged areas should be ground back to sound laminate and repaired with epoxy resin matting and colour-matched gelcoat. Trim tabs are screwed to the stern. They did not work and should be repaired or replaced.

Repair cracking found on the hull; Repair the cracking found on the superstructure.

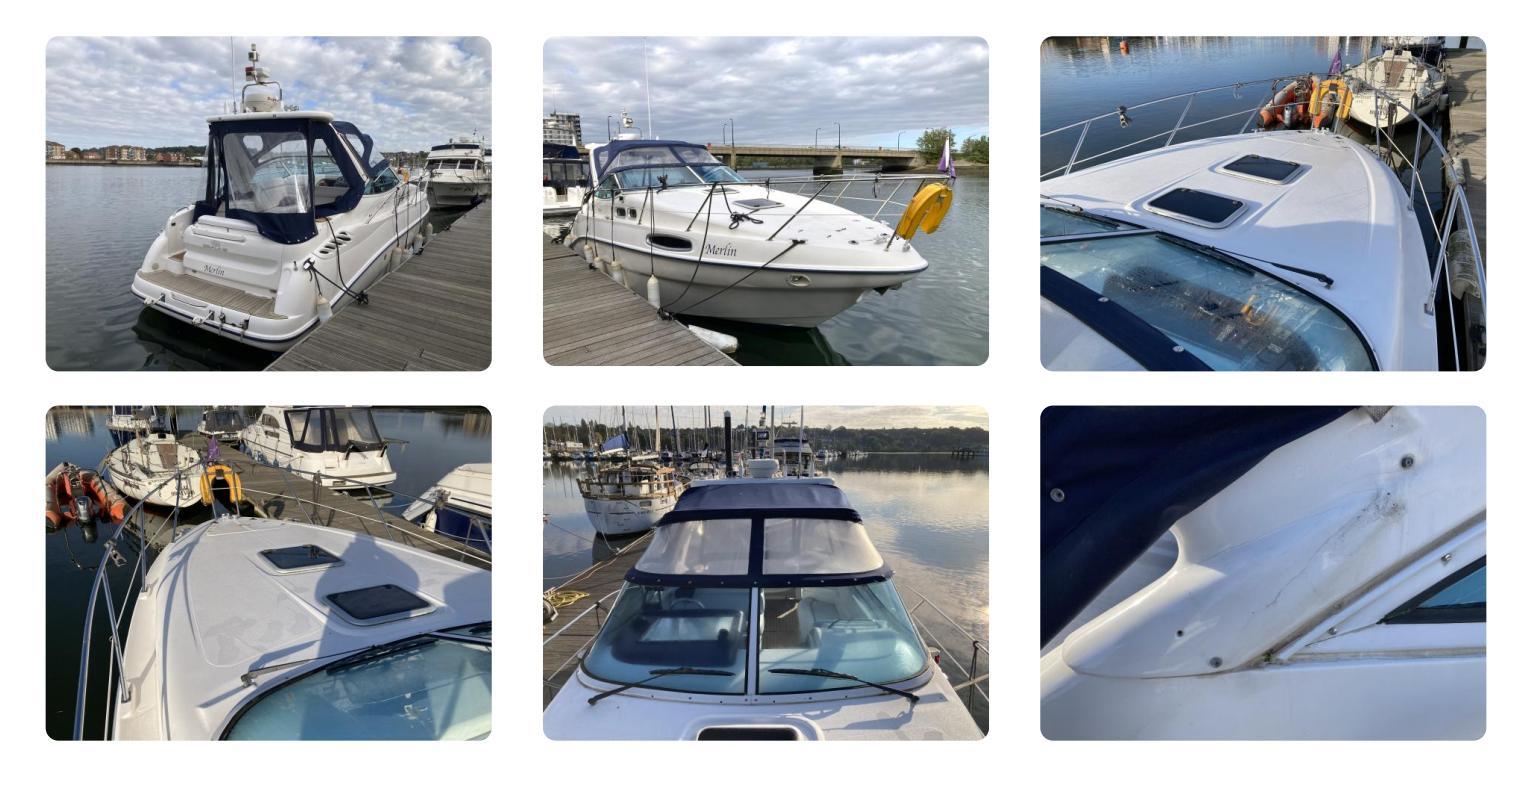
Cracking due to minor accident damage was found on the starboardside of the deck around the second from aft stanchion base and on both sides of the radar arch. The cracks should be ground back to sound laminate and repaired with colour-matched gelcoat.

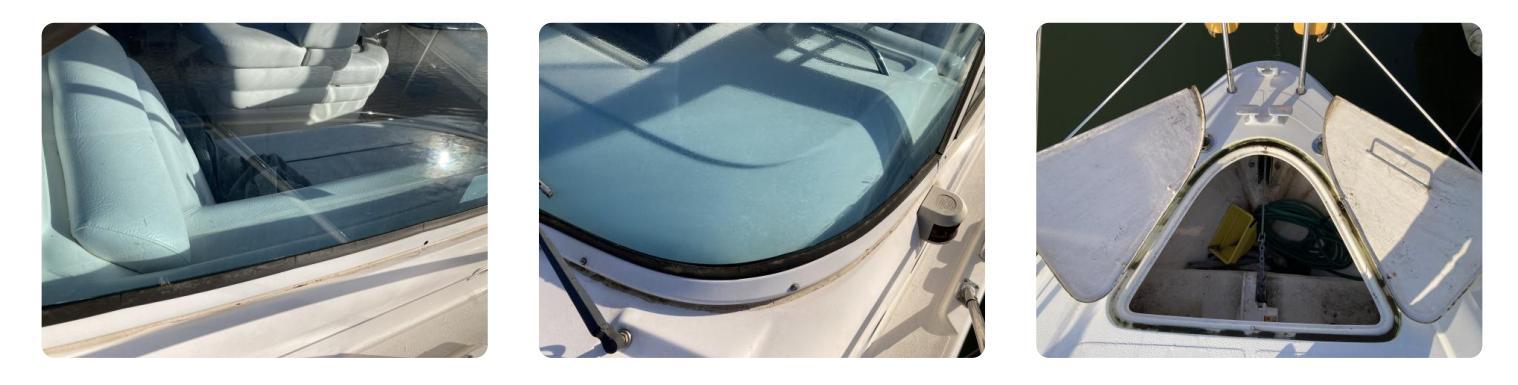
A working electric anchor windlass is bolted to the inside of the anchor locker. Its cockpit switches and deckmounted 'down' switch worked well, but its deck-mounted switches are faulty and should be replaced. A fourpiece glass windshield surrounds the cockpit. It's seals/gaskets are badly perished and should be removed and refitted with new gaskets.

Clean the propellers of fouling and test the engines again during a second sea trial; Replace the deckmounted anchor windlass switches; Remove and refit the windshield using new gaskets; Consider replacing all 12-volt batteries; Repair or replace the autopilot; Repair or replace the electronic compass.

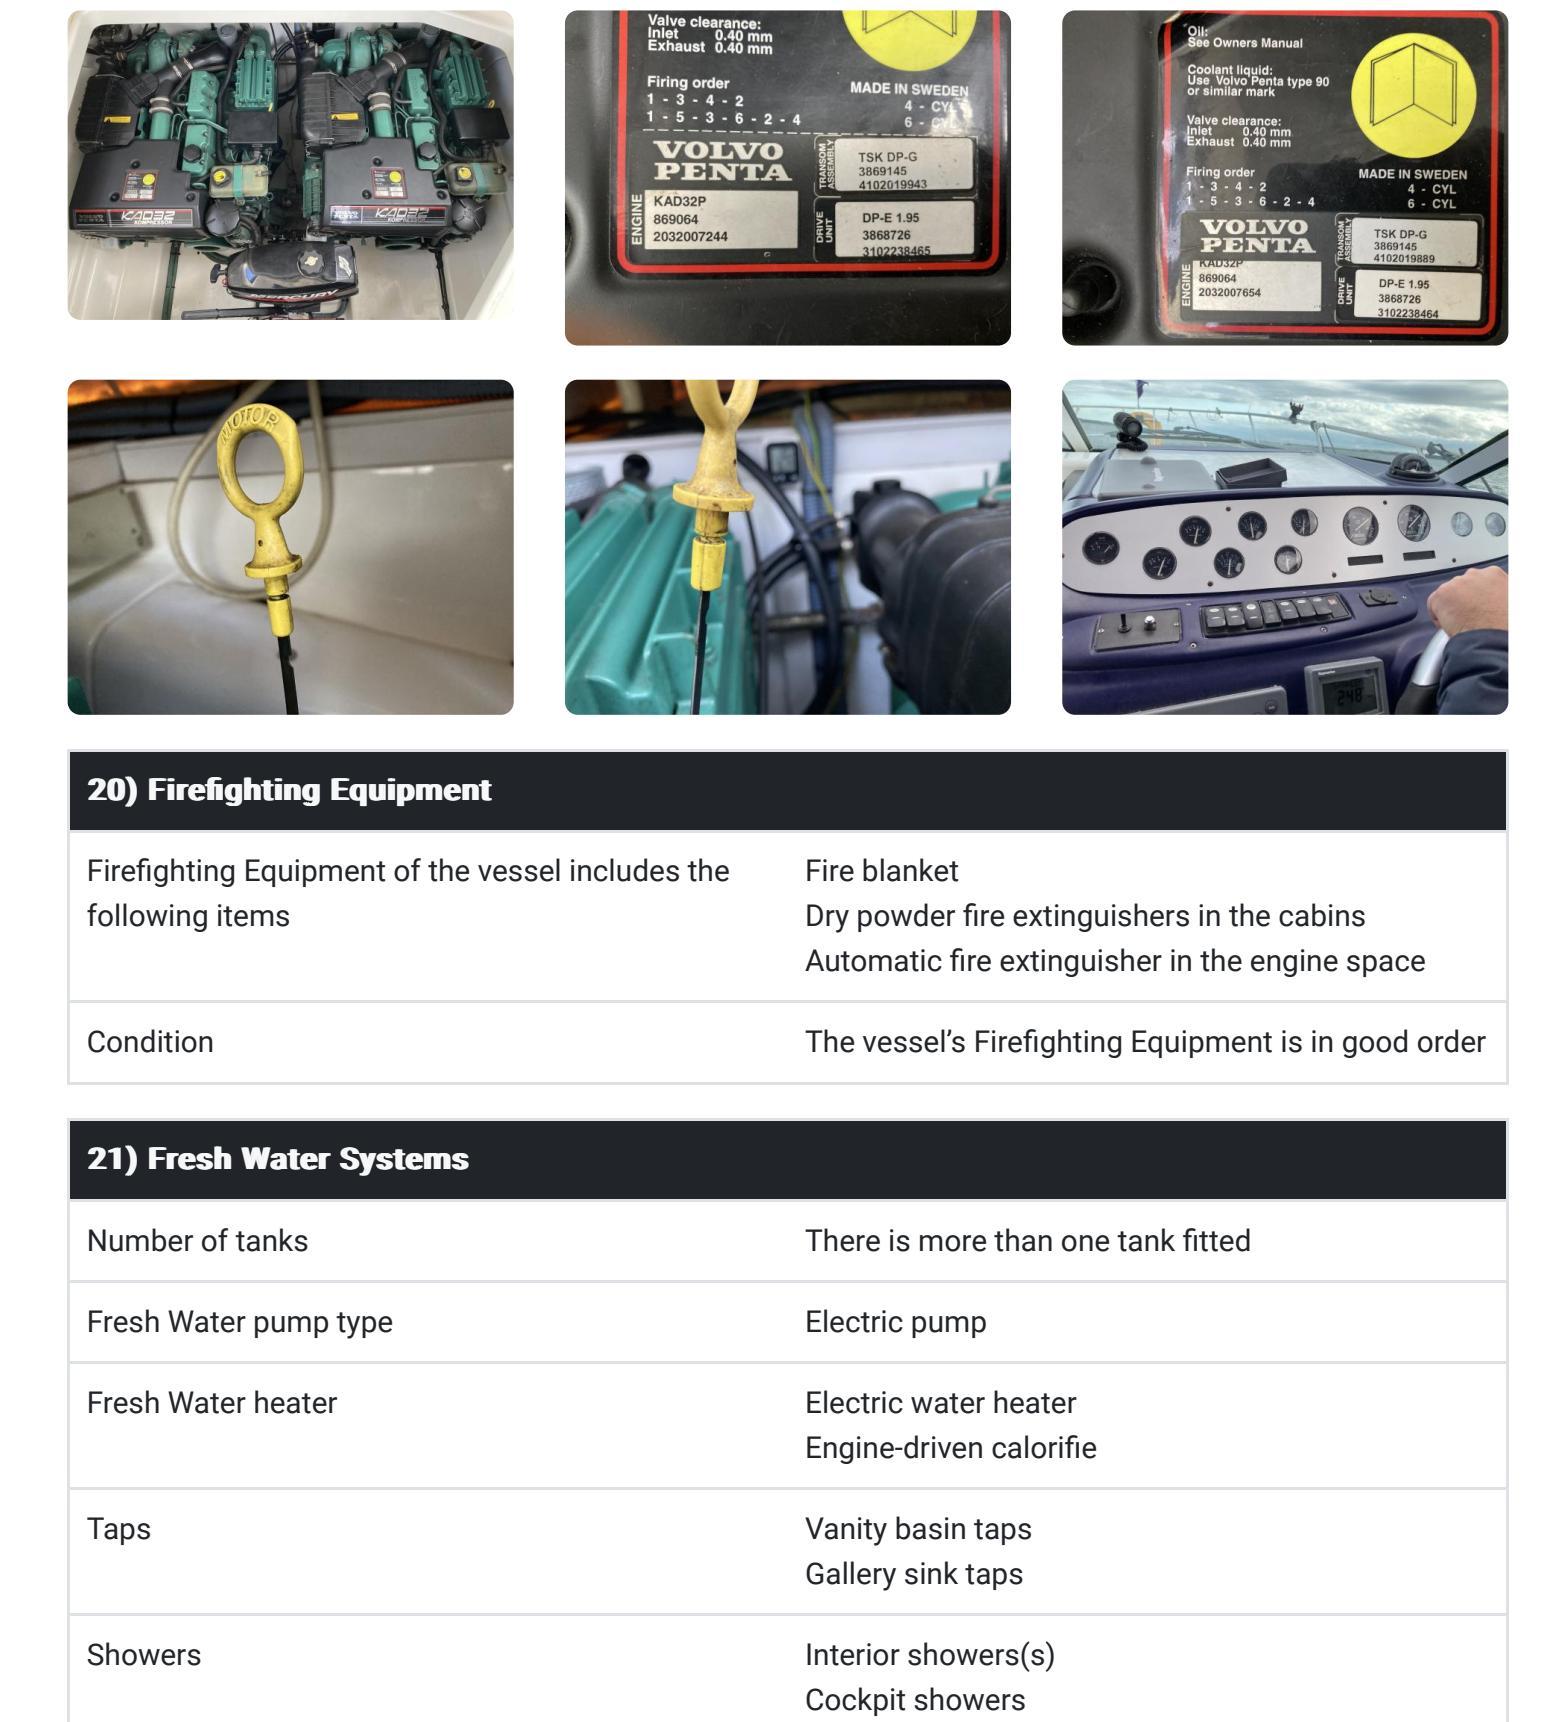
The portside engine number is 2032007244 and the starboardside engine number is 2032007654. The portside engine hour meter read 601 hours and the starboardside meter read 618 hours. The engine control levers are free to move and well located in the cockpit. There are fuel cut-off taps with remote controls and water intake strainers. The engines started easily and ran well during the inspection. The coolant systems worked properly, and the engine and sterndrive oils were found to be at the correct level and clean. Ancillary equipment, such as the alternators, fresh water header tanks, raw sea water coolant strainers and stop solenoids, worked well. The engine oil dipstick O-ring seals are missing and should be replaced. During the sea trial, the engines each ran at a maximum of 3,400 RPM. The vessel reached a maximum speed of twenty-eight knots, which was measured with and against the tide using the vessel's GPS. However, it should be noted that KAD32P engines should be able to run up to 3,800 RPM and the vessel should be able to reach thirty knots. It is likely that the revs and speed have been affected by the fact that the trim tabs did not work and that the propellers were slightly fouled with barnacles. The trim tabs should be replaced and the propellers should be cleaned before a second sea trial takes place.

Repair or replace the trim tabs; Replace the flexible gas hose; Replace the gas regulator with a marine regulator that is compliant with ISO 10239 Annex M; Replace the missing engine oil dipstick O-ring seals; Have the engines and sterndrive units inspected and serviced by a marine engineer.

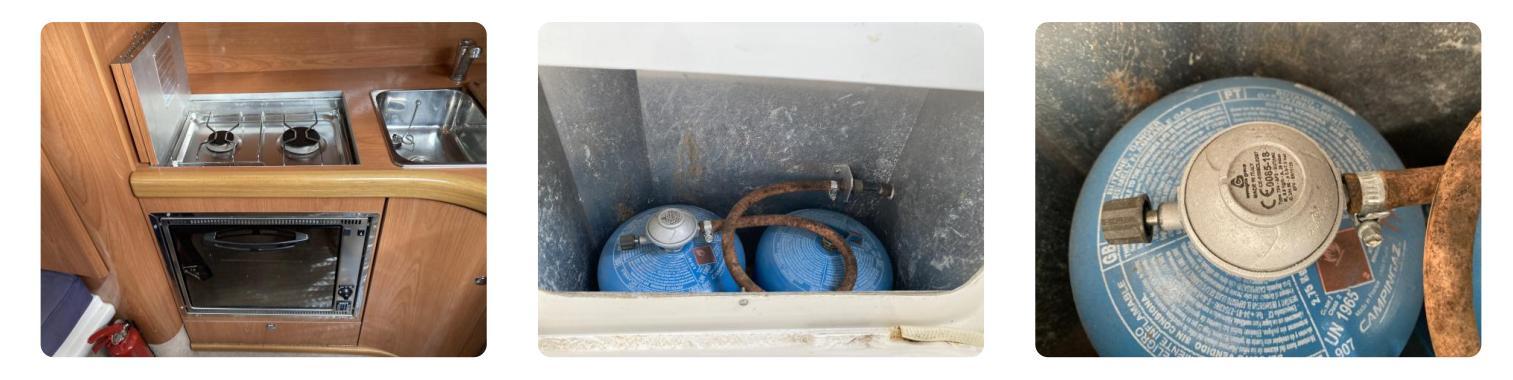
The flexible gas hose should be replaced, as it is more than five years old. The gas regulator is not of marine grade and should be replaced with a regulator that is compliant with ISO 10239 Annex M. The gas system was otherwise found to be in good order.

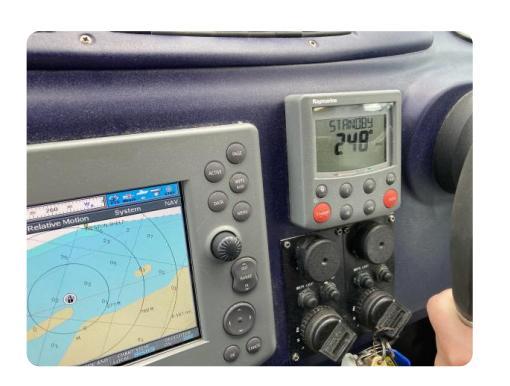
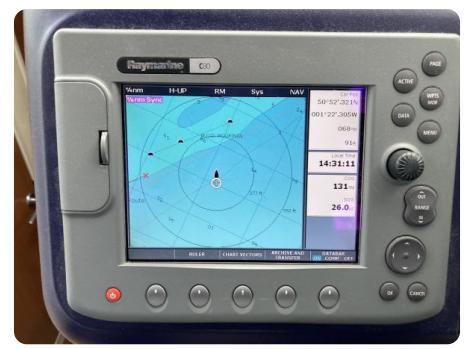
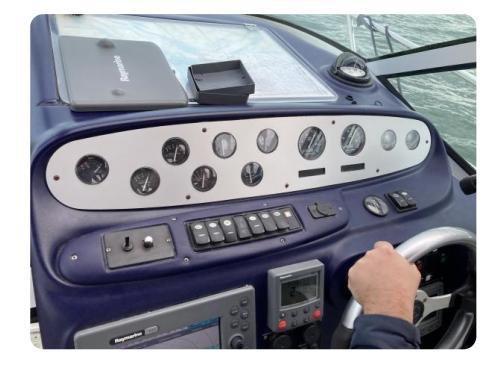
The autopilot and fluxgate compass are faulty and should be repaired or replaced.
