OMEGA YACHT SERVICES Glenmist, Mount Pleasant, Stoford, Salisbury, SP2 0PP Tel: 07702 915524

Pre-purchase, Condition, Insurance and Valuation Report

Merlin

3) Vessel details		
Vessel type	Motor Vessel	
Model	Sealine S28	
Builder	Sealine International Ltd	
Designer	Tom Murrant	
Identification	Registration number none displayed Year of construction 2004	Serial number 393 Hull number GB-SIL28393K405
Engine	Volvo Penta KAD32P x 2	
Accommodation	Four berths in two cabins	
Dimensions listed from	Manufacturer's website	
Dimensions	Overall length 8.8m Beam 3.1m	Hull length 8.2m Draft 1.0m
Fuel capacity	400 litres	
Water capacity	280 litres

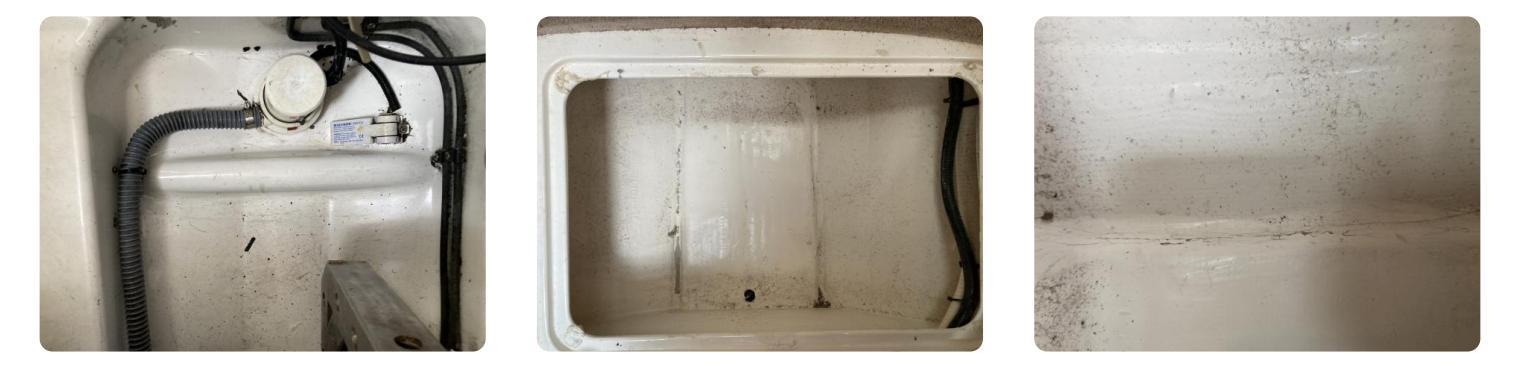
8) Bulkheads and bondings		
Bulkhead and Bondings	The vessel is stiffened by bulkheads of marine plywood. The hull is further stiffened by plywood semi-bulkheads in the cabin and locker dividers, all of which are properly attached with well-wetted glassed-in bondings. All the bulkheads were properly bonded to the inside of the GRP hull with glass-fibre matting and resin, and all were found to be in sound condition.

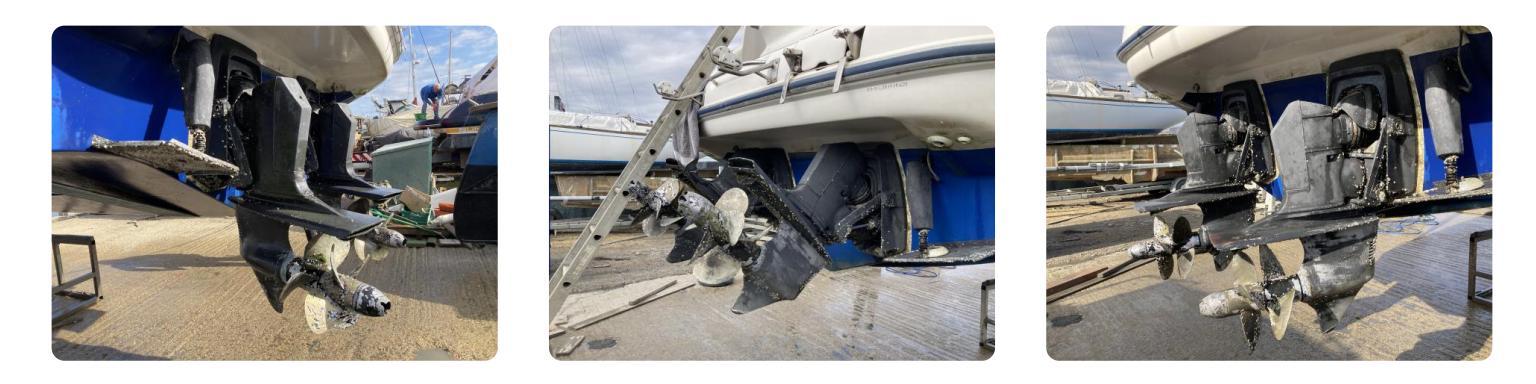
11) Rudder

The Stern Gear was found to be in good order
